LEO JOURNAGAN LAKE
GREENE COUNTY, MISSOURI
MO 20395

**PHASE 1 INSPECTION REPORT
NATIONAL DAM SAFETY INSPECTION**

PHASE I INSPECTION REPORT
NATIONAL DAM SAFETY PROGRAM

Anderson Engineering, Inc. Springfield, Missouri
Hanson Engineers, Inc., Springfield, Illinois

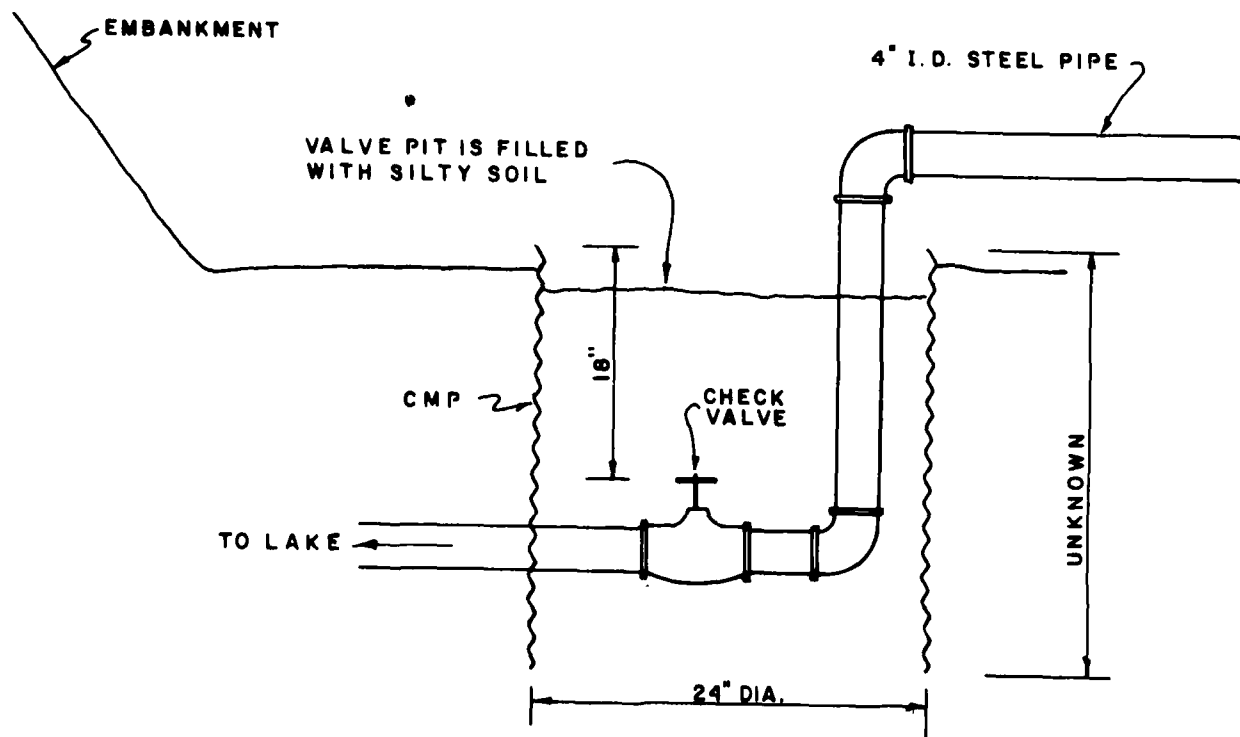
LAKE DRAWDOWN VALVE PIT

A dewatering pipe was found at the downstream toe of the embankment at sta. 3 + 86. The four-inch I.D. steel pipe comes out of a 24 inch diameter CMP valve pit covered with a steel lid. The valve is a gate valve and the control wheel is located 18 inches below the top of the pit. At the time of the inspection the valve pit was filled with silty soil. The four-inch pipe was not seen on the upstream side, therefore, it must be below the lake level, elevation 91.83, at the time of inspection. A detail of the dewatering valve pit is included on Sheet 4 of Appendix A.
